# Tornado Rating Document

## Weiler (Baden-Württemberg) Germany 07 JUN 2021

**Date:** 07 JUN 2021  
**Time:** 1730 CEST / 1530 UTC  
**Country:** Germany  
**State:** Baden-Württemberg  
**Place:** Weiler (Rainau com.)

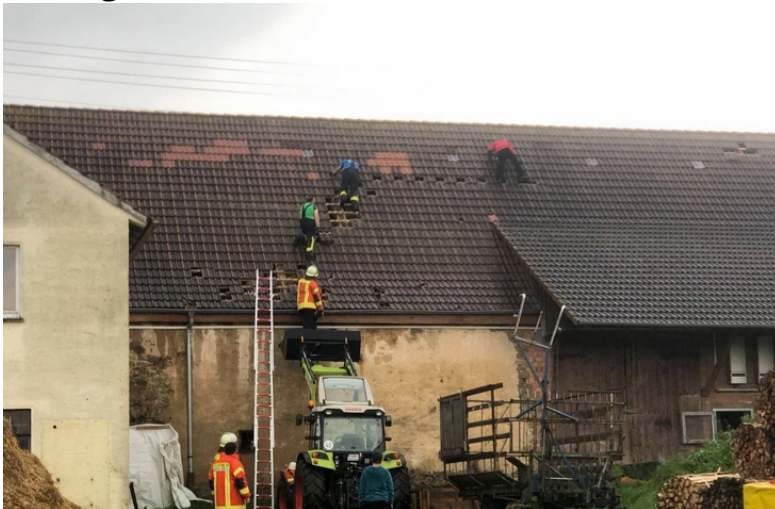
#### 01 Large barn (48.9096N 10.1772E)

Some slates blown down from the roof on the north side of the building.  
DI Roofs, DoD1 (<20% loss ratio): IF0+ / F0T1.

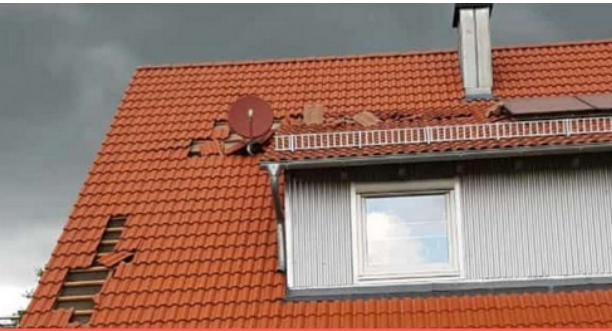
### 03 Residential building (48.9083N 10.1781E)

Some slates blown down from the roof on the north side of the building.  
DI Roofs, DoD1 (<20% loss ratio): IF0+ / F0T1.

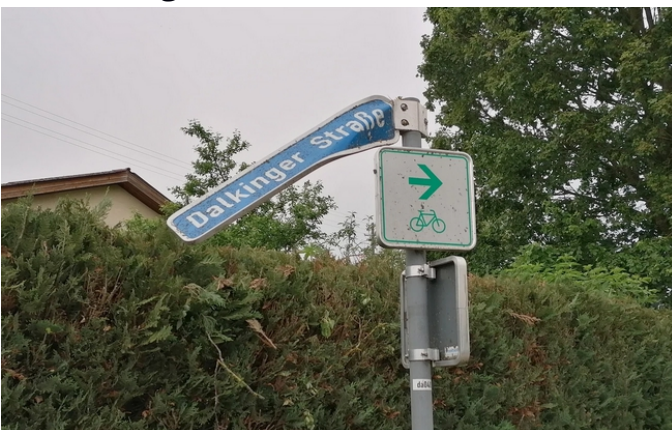
### 04 Road sign (48.9094N 10.1777E)

Damage very likely not caused by wind force, but by falling tree or large branches.

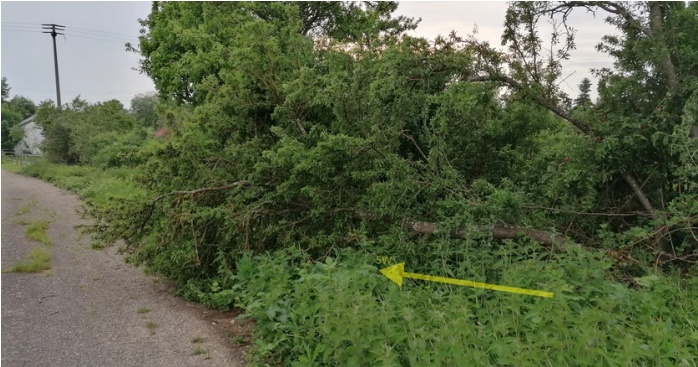
### 06 Shrubs (48.9086N 10.1787E)

Broken directly over ground.  
DI IX Shrubs, DI Sub b (avg.), DoD4 results in F1 (likely low end F1) / F1T2.
